### Yorkshire Vernacular Buildings Study Group

## STATION HOUSE - CASTLE HOWARD (REPORT 1667)

AUGUST 2004

Station House

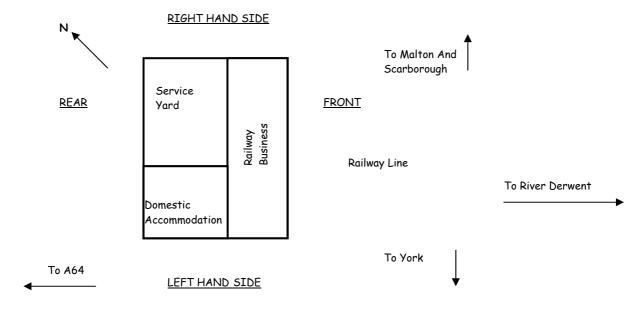
FIGURE 1 - ORIENTATION OF THE BUILDING AND GENERAL LAYOUT

The convention used to describe features is to look at the house from the railway track and treat the platform face as the front. A sketch of the convention is given below in Figure 1.

The general plan of the building is given above in Figure 1. A block plan showing the layout during the railway period is attached in Appendix A. The detailed plans are also attached in Appendix A. There is a redraft of the 1915 plan and an updated plan to show the subsequent changes. There is also a plan of the first floor of the two-storey sections and two elevations of the building. Photographs are attached in Appendix B. Old photographs are attached in Appendix C, which include the old signal box just prior to demolition.

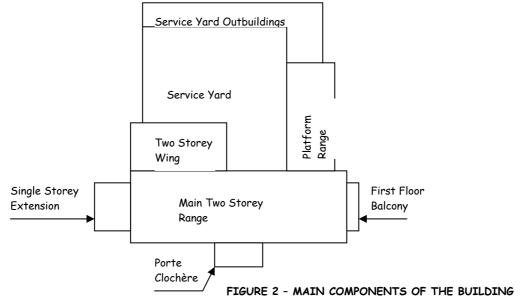
Externally the building can be divided into three principal sections. The sections are the main two-storey range, the two-storey wing and the platform range. These are shown below in Figure 2. Also shown in Figure 2 are the three additions to the main two-storey range and the service yard with its outbuildings.

On the left hand side there is a two-storey range. This range has been finished to a high standard using an Italianate style. There is a two-storey porte-clochère near the centre of the elevation and the arrangement of the windows almost provides a balanced façade. On the front, there is a balcony at first floor level supported on four curved brackets; a stone feature projects through the roof above the balcony. At the rear of the two-storey range there is a two-storey wing set parallel to the platform. There is a single storey extension at the rear set in-line with the main two-storey range. The platform range at the front is single storey and is also finished to a high standard except the architectural motifs have been simplified. Finally there is the service yard to the rear including some outbuildings. This section has been executed in a more workmanlike manner, which reflects its lower status.

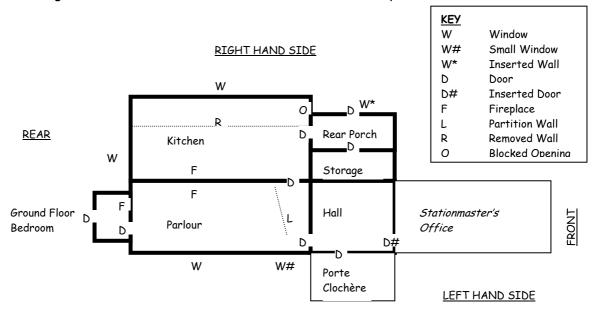
FIGURE 3 - DOMESTIC ACCOMMODATION - GROUND FLOOR

The ground floor layout includes a bedroom, the parlour, the kitchen, a lean-to and the hall. All of these rooms are accessible via the front door at the back of the porte-clochère, which leads into the hall. The hall also contains a staircase to the first floor rooms. On the ground floor, the hall led originally only into the parlour; the doorway into the former stationmaster's office was only created in 1986. The three principal domestic rooms on the ground floor are heated. Internal walls have been removed; originally there was a corridor through the parlour into the kitchen comprising a lightweight partition. It was shown on the 1915 plan and the fixing points can still be seen on the floor. This corridor was lit by a small window in the left hand wall (note the convention and Figure 3 above) near to the rear wall of the porte-clochère. The kitchen was originally subdivided; the section at the right hand end (note the convention) was a pantry. A rear lean-to has had a wall added to convert it into a rear porch so the back door no longer opens directly into the service yard.

The internal walls are generally as the external walls being between 20" to 25" thick. The exceptions are the hall walls that are only 12" thick. The wall forming the right hand wall of the storage room is a 9" brick wall. The only other brickwork appears to be the walls around the sides of the ladies toilet and the chimney breast in the ladies waiting room. The floors are all solid. The hall floor is made up of black and red tiles set in a diamond pattern. The parlour floor comprises flagstones. The ground floor bedroom has a timber floor which was previously damp until it was sealed. The kitchen floor comprises red bricks.

The levels vary and this is a reflection of the sloping nature of the site. There is a step up into the property at the main entrance. There is another step up into the parlour from the hall. There is another step up from the parlour to the ground floor bedroom. The kitchen backdoor steps down into the service yard.

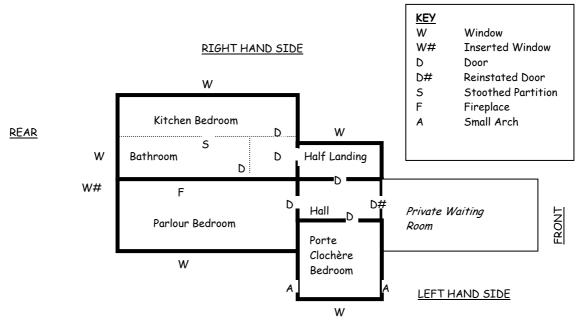
FIGURE 4 - DOMESTIC ACCOMMODATION - FIRST FLOOR

Upstairs, there is a small bedroom over the porte-clochère, though its right hand wall is set to the right of the left hand wall (note the convention and refer to Figure 4 above) of the main two-storey range. This wall appears to be supported by a downstand beam visible in the ground floor hall ceiling. There is a second bedroom, the parlour bedroom, over the parlour, which was heated. There is a third bedroom, the kitchen bedroom, located over the kitchen but this was subdivided in 1915 to create an inside bathroom. The porte-clochère and parlour bedrooms are entered directly from the main staircase. The kitchen bedroom is entered from a spur staircase via an intermediate, or half landing, off the main staircase. The sitting room on the first floor, over the stationmaster's office did not form part of the domestic accommodation.

The ceiling of the porte-clochère bedroom has been lowered by about 12". There is access into the roof space via a number of hatches. The roof structure comprises king post principal trusses set at about 7' centres with common rafters, ridge board and single inclined purlins on each side; the purlins are not continuous. There are five king post trusses. The timber used in the roof is generally about 3" wide. The purlin is  $5\frac{1}{2}$ " high and the rafters are 4" high. The walls all stop at eaves level. There is also access into the two-storey wing loft. This roof structure is the same though there is only one king post truss. The base of the stacks are clearly visible in the left hand end of the two-storey wing loft though the equivalent stacks at the front are not; this implies the wing was contemporary with the main two-storey range.

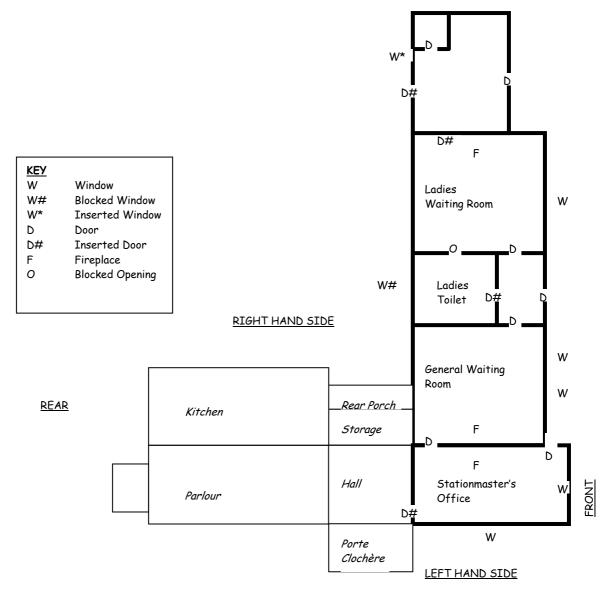
FIGURE 5 - RAILWAY BUSINESS - GROUND FLOOR

The private waiting room used by the Earl of Carlisle is reached via the front door on the left hand side and the main staircase. It is a heated room. On the front elevation of this room, there is a balcony overlooking the railway. From close inspection of the balcony, it is apparent it is intended for show. Not only is the access onto the balcony difficult, but the finishing of the stonework is workmanlike. Also, access is via a sash window and would not be an exercise undertaken lightly. The stone making up the balcony is squared and no attempt appears to have been made to shape or curve the balustrading. There is another window in

the left hand wall formerly overlooking the sidings. This private waiting room is above the stationmaster's office. The doorway between the office and the hall is a recent insertion. There are also two doorways into the office in the right hand wall. The rear leads to the general waiting room; the front doorway leads onto the platform, which is set higher than the stationmaster's office floor. There is a window on the front elevation and on the left hand side. Any evidence of the internal layout of the stationmaster's office has gone, though the 1915 plan provides hints. There has been speculation about a cellar but there is no sign of any scarring of the stonework on the left hand elevation; it is more likely that there was sufficient storage in the service yard.

The stationmaster's office has a suspended timber floor. The fireplace has been removed though the chimney breast can still be seen. There is a simple cornice and a picture rail. A feature that was removed in recent years was a wooden staircase leading from the stationmaster's office to the private waiting room; this staircase was not shown on the 1915 plan so its inclusion and use reflects some change in priorities and room usage at the station.

The passenger accommodation is shown above in Figure 5. This includes the single storey platform range and one of the service yard outbuildings set parallel to the railway line. It includes a general waiting room, a ladies waiting room and a ladies' toilet. The men's toilet was in one of the service yard outbuildings at the right hand end of the platform range. The platform range is heated with a fireplace at each end; the left hand flue is in the main two-storey range stonework whereas the right hand flue is constructed from brickwork, which can be seen in the loft. A later doorway has been created at the rear of the right hand end leading into the former men's toilet. The doorway to the ladies toilet has been moved from the right hand wall to the front wall.

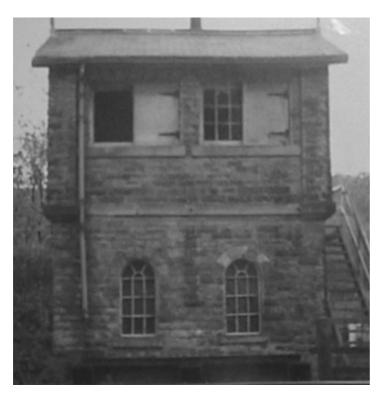
#### SIGNAL BOX

These are copies of photographs of the old signal box taken in 1979 just prior to demolition. It was a stone built with a slate roof and an external wooden staircase on the side facing the level crossing.

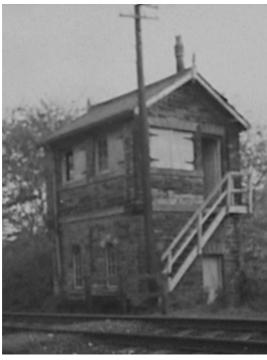
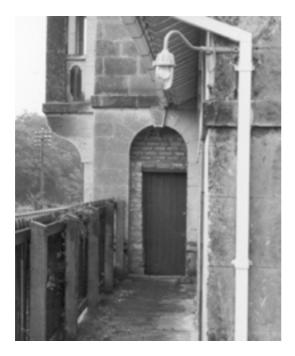
#### STATIONMASTERS PLATFORM DOOR

The above views are of the stationmaster's office door leading onto the platform. The opening had been reduced using a brick infill and a small door inserted. This opening has been opened up and can be seen in Appendix B.

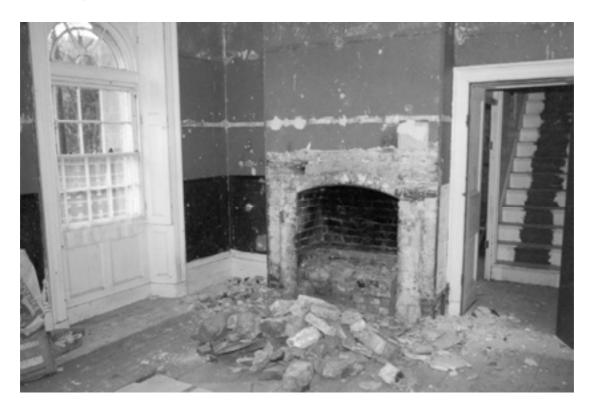
#### PUBLIC WAITING ROOM

This is inside the public waiting room looking towards the stationmaster's office. The foot of the stairs leading to the former private waiting room can be seen. The construction of the fireplace with its brick lining can also be seen. On the left hand side of the view, the form of the windows can be seen.

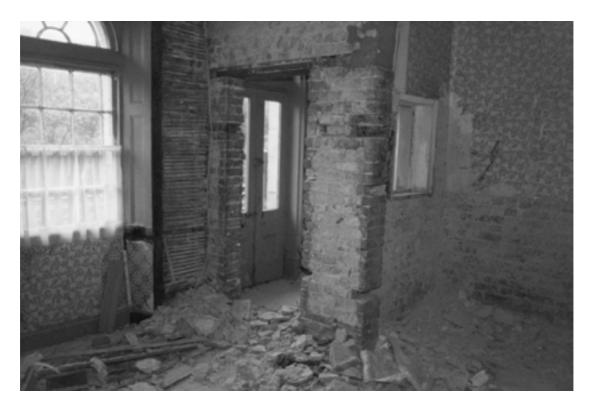
This view is from the former ladies waiting room looking towards the platform and the former ladies toilet. The construction of the internal walls is apparent comprising brickwork.

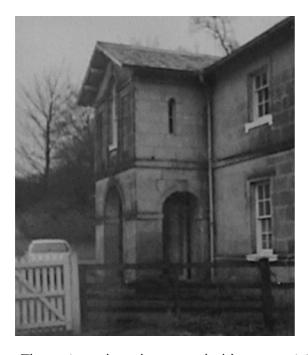
#### PORTE CLOCHÈRE

These views show the porte clochère was originally open. In the late 1990's it was glazed to improve conditions in the bedroom above.

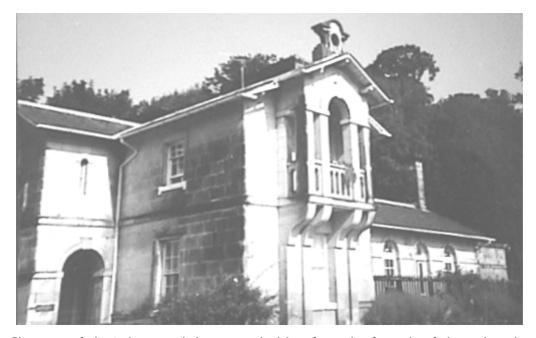
Elevation of the balcony and the porte clochère from the far side of the railway line.

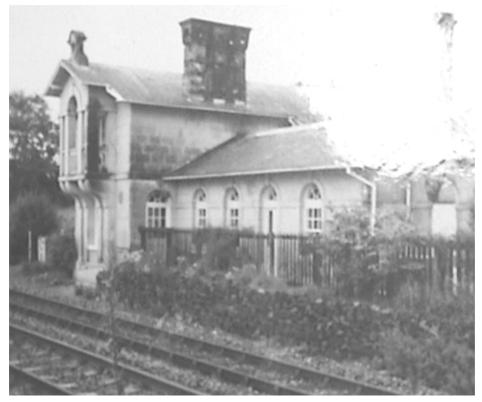
View along the platform range towards the main range with the first floor balcony.

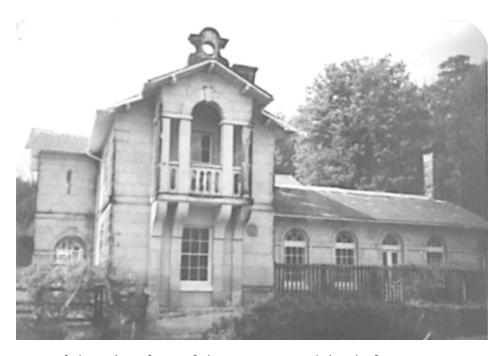
View of the railway faces of the main range and the platform range.

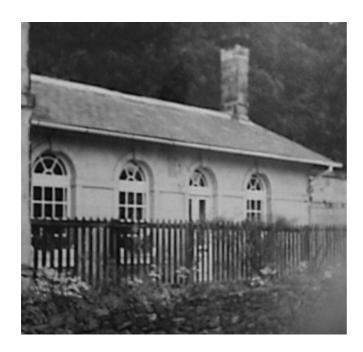
Detail of the railway face of the platform range.

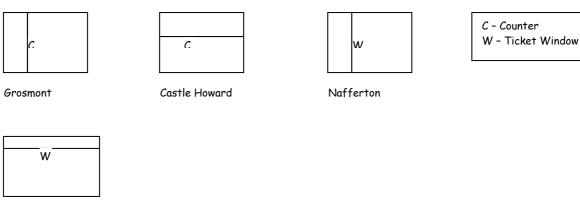
A feature common to all of the station houses except Castle Howard is the canted bay on the platform. This is located in the stationmaster's office and provided clear views up and down the track. It is curious why such a detail was not present at Castle Howard though there is an indirect detail. The stationmaster's office has a door leading onto the platform, which would afford views along the track towards Malton. There is also a window on the opposite wall affording views towards York. It is not known if the lack of the canted bay caused any problems. There are two possible explanations for the omission of the canted bay. It may have detracted from the detail of the elevation with its balcony. Another possible reason for the omission could be simply down to the fact the railway is on a continuous curve within woodland and the sightlines were too poor. That said, the station at Kirkham Priory is also located on a curved piece of track and it had a canted bay though there was not any woodland to limit the view.
